**KEHR'S MILL TRAIL LOWER DAM  
ST. LOUIS COUNTY, MISSOURI  
MO 11277**

**PHASE 1 INSPECTION REPORT  
NATIONAL DAM SAFETY PROGRAM**

**NOVEMBER 1980**

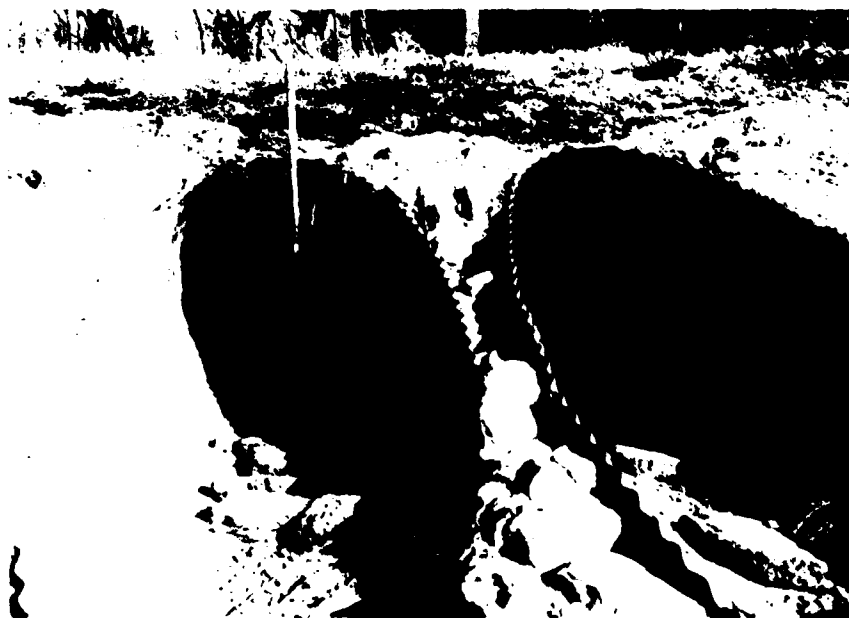
(1) The spillway appears to be in good condition. The lake level at the time of the inspection (El. 504.4) was below the spillway pipe inlet invert. There was an accumulation of debris at the pipe inlet (Photos 7 & 8) and trees were beginning to develop at the outlet (Photos 9 & 10) which could reduce the capacity of the spillway pipes. The channel downstream of the spillway was grown up with trees and brush but should not effect the capacity of the spillway.

PHOTO 8: INLET TO SPILLWAY PIPES
